CALIFORNIA CROSSROADS

Stage 3 Road Safety Audit – GG119 Decision Log

UK-70104511/RSA3/1/0 January 2025

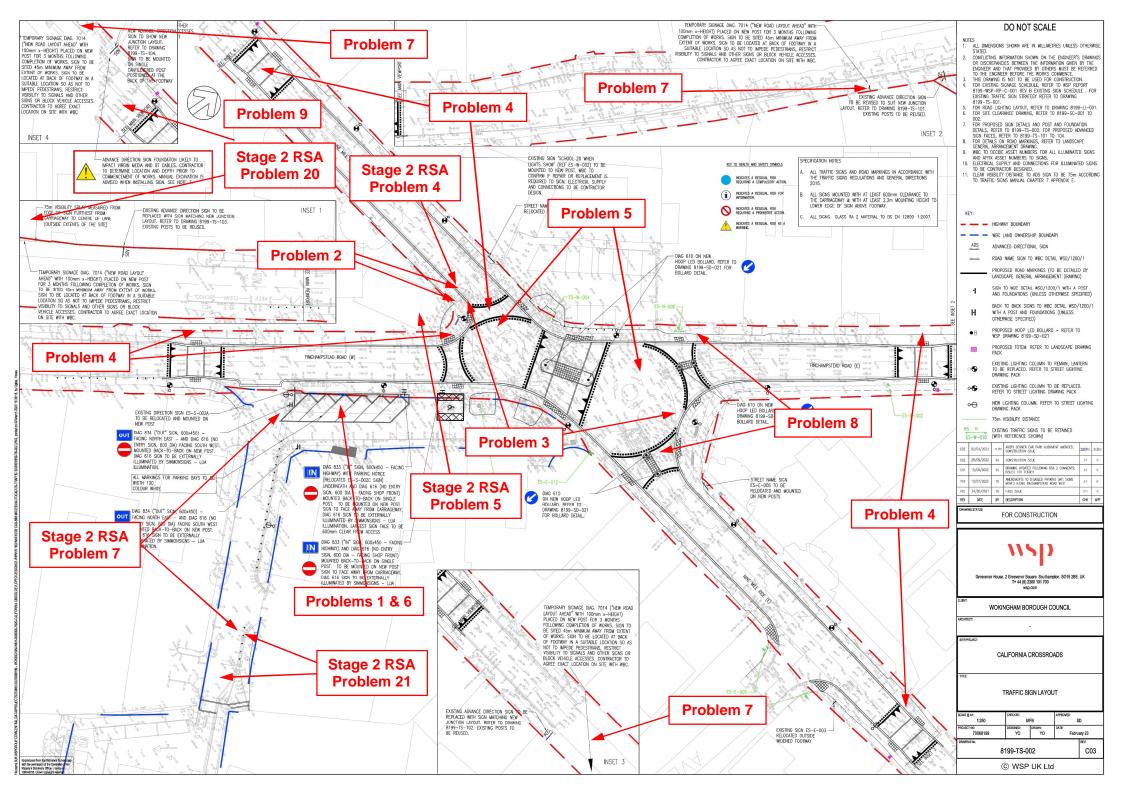
PROBLEM LOCATION PLAN

RSA3 problem	RSA Recommendation	Design Organisation Response	Overseeing Organisation Response	Agreed RSA action
 Problem 1 Location: Parking area for the shops on the south side of the California Crossroads junction – see Appendix B for location. Summary: Removal of the footway could increase the possibility of conflicts between pedestrians and vehicles in the parking area. In the previous road layout in this location, there was a footway provided adjacent to the row of shops on the south side of the California Crossroads junction. This footway has been removed as part of the scheme. It was observed during the site visit that several pedestrians were walking through the centre of this area in locations where vehicles will be turning into or out of the echelon parking bays (as shown on the photograph below). Anecdotal comments from some members of the public suggested that the new layout has increased the possibility of conflicts between vehicles and pedestrians walking through the parking area. 	It is recommended that appropriate 'virtual footway' road markings are provided at the back of the parking area (directly adjacent to the shops) in order to encourage pedestrians to travel through this area away from the locations where vehicles will be turning into or out of the parking bays.	 Recommendation Rejected The design layout conforms with the guidelines within Manual for Streets, which states that shared use spaces are likely to work well In short lengths or where they form cul-de-sacs Where motor vehicle traffic is below 1—vehicles per hour, and Where parking is controlled or takes place is designated areas WBC are considering commissioning WSP to film the operation of the crossings over a couple of days to assess their performance. WBC to confirm if this commission should be 	Reject Auditors Recommendation and Accept Designer Responses: In the previous arrangement, pedestrians (in addition to those accessing their vehicles) would walk in the road, into areas where drivers were reversing out of parking spaces. As there wasn't enough room to expand the footpath, the new layout eliminates the delineated footpath. Consequently, drivers should now expect pedestrians in their path from time to time, fostering increased driver awareness of a situation that was happing informally before. Additionally, drivers are now required to reverse into the parking spaces, so they can drive out forwards, which	We are mindful of public feedback, so WSP will review video footage and gather observations before the RSA 4 is undertaken.

RSA3 problem	RSA Recommendation	Design Organisation Response	Overseeing Organisation Response	Agreed RSA action
 Problem 2 Location: South-western corner of the California Crossroads junction – see Appendix B for location. Summary: Petrol station signage could present an obstruction on the footway as well as further restricting the visibility to / from the adjacent pedestrian crossing points. As shown on the following photograph, there is a temporary petrol station sign and a 'coffee cup' feature positioned on the new footway on the south-western corner of the junction. During the site visit, it was observed that the adjacent petrol station fuel price totem restricts the visibility to / from the adjacent pedestrian crossing points (see Problem 4 in Section 2.3 of this report), and the temporary sign and 'coffee cup' feature could further restrict the inter- visibility at the crossing points. This could increase the possibility of a driver not clearly seeing a pedestrian waiting at one of the adjacent crossing points (particularly a child pedestrian or a wheelchair user), which could increase the possibility of a pedestrian crossing the carriageway when a vehicle is turning onto Nine Mile Ride (West) or Finchampstead Road (South), possibly leading to a collision. In addition, the temporary sign and 'coffee cup' feature could present an obstruction on the footway which could increase the possibility of a pedestrian tripping over one of these features (particularly a visually impaired pedestrian). 	It is recommended that the temporary sign and 'coffee cup' feature are removed or relocated to an alternative appropriate location where they will not obstruct any footways or visibility sight lines.	Recommendation Accepted WBC to discuss with the fuel station owner to remove or relocate the temporary sign and coffee cup feature to increase visibility at the pedestrian crossing point.	WBC to discuss location of the features with petrol station owner. Features will be requested to be moved back to sit closer to the kerb line of the station forecourt.	WBC to instruct the petrol station owner that the features are moved to the back of the footway before the RSA 4 is undertaken.

RSA3 problem	RSA Recommendation	Design Organisation Response	Overseeing Organisation Response	Agreed RSA action
 Problem 3 Location: South-western and north-eastern corners of the California Crossroads junction – see Appendix B for locations. Summary: Vehicles observed overrunning the footways when turning left onto Nine Mile Ride (West) and Nine Mile Ride (East). It was observed during the site visit that occasionally vehicles were overrunning the footways on the south-western and north-eastern corners of the junction, when undertaking the left-turn movements onto Nine Mile Ride (West) and Nine Mile Ride (West) and Nine Mile Ride (East). This could increase the possibility of a vehicle colliding with a pedestrian on the footway. 	It is recommended that this problem is specifically monitored during the initial months after opening to ascertain how regularly vehicles overrun the footways in these locations. This could be undertaken by utilising the CCTV equipment at the junction. If it is concluded that vehicles are periodically overrunning these footways, it is recommended that appropriate mitigation measures are installed (such as the provision of reflective bollards on the footway, adjacent to the kerbline). It is also recommended that a Stage 4 monitoring Road Safety Audit is completed for this scheme (when 12 months of personal injury collision data becomes available) in order to review how the new junction layout is operating in relation to this issue.	Recommendation Accepted WBC are considering commissioning WSP to film the operation of the crossings over a couple of days to assess their performance. WBC to confirm if this commission should be extended to assess the operation of this area.	Accepted. WBC have approved commission to assess crossing performance. The findings will be discussed and reviewed within RSA 4.	WSP to review video footage and feedback observations before RSA 4 is undertaken.

RSA3 problem	RSA Recommendation	Design Organisation Response	Overseeing Organisation Response	Agreed RSA action
 Problem 4 Location: Various new 'courtesy crossing' facilities – see Appendix B for locations. Summary: Possibility of a pedestrian crossing the carriageway when a vehicle has stopped on one approach to the crossing facility, and then being struck by another vehicle travelling in the opposite direction. Various new pedestrian crossing facilities have been provided throughout the extents of the scheme with road markings (similar to dashed 'give way' markings) provided on the carriageway either side of each crossing. During the site visit, it was observed that most vehicles stopped to give way to waiting pedestrians at these 'courtesy crossing' layouts, although some motorists did not stop when a pedestrian was waiting to cross the road. Due to the ambiguity of priorities at these crossings, potentially a pedestrian could see a vehicle stopping as it approaches from the right and then start walking across the carriageway. However, the pedestrian may not look to the left to check whether any other vehicles approaching in the opposite direction have also stopped to let them cross the carriageway. Therefore, this could result in the pedestrian being struck by a vehicle approaching from the left. This could be a particular problem at the new 'courtesy crossing' facilities with no pedestrian refuge islands in the centre of the carriageway, where pedestrians can cross the carriageway in two movements by waiting on the island. 	It is recommended that appropriate "Look Both Ways" road markings are provided on the carriageway or on the footways adjacent to the crossing points, at the new 'courtesy crossing' facilities without any pedestrian refuge islands in the centre of the carriageway.	Recommendation Rejected We can assess the available space for the markings; however, it could give the false impression that drivers have priority over pedestrians. It is advised the crossings are monitored further, to understand if pedestrians are looking in both directions and the level of courtesy drivers are providing.	Reject Audit Response and Accept designer response: Accept designer response that inclusion of recommended wording could provide a false driver impression regarding priorities, and findings from crossing survey report that has been commissioned will be reviewed and considered in line with RSA4.	WSP and WBC to review available video footage and feedback observations before RSA 4 is undertaken.

RSA3 problem	RSA Recommendation	Design Organisation Response	Overseeing Organisation Response	Agreed RSA action
 Problem 5 Location: New layout of the California Crossroads junction – see Appendix B for location. Summary: New junction layout could be confusing to road users. The proposed scheme has replaced the previous double mini-roundabout junction layout and replaced it with an unconventional junction layout where it may not be completely clear to road users who has priority when travelling through the junction. However, map-type advance direction traffic signs have been installed (or are planned to be installed) on each approach, which shows that the junction has a double-roundabout layout. It was observed during the site visit that motorists were generally using the junctions like mini-roundabout layouts (i.e. they were giving way to the right when entering the junction from one of the approaches). However, due to the unusual layout, occasionally some road users (particularly those travelling through the junction in a cautious manner, however this could also increase the possibility of a motorist entering one of the junctions and not giving way to another vehicle approaching from the right (which may lead to a collision) or a road user could be concentrating on how to negotiate the junction and then failing to give way to a pedestrian crossing the 	It is recommended that appropriate mini- roundabout central island road markings to TSRGD diagram 1003.4 (with the circular central island marking and the arrow markings) are provided in the centre of the two individual junctions at California Crossroads. This could reduce driver confusion, provide a more conventional junction layout, and encourage road users to give way to the right at the 'roundabout' entries.	Recommendation Rejected The auditors have noted, "During the site visit, it was observed that motorists were generally using the junctions like mini- roundabouts (i.e., they were giving way to the right when entering the junction from one of the approaches)," which suggests that the junction is operating as intended. Adding a roundel might detract from the current scheme approach. However, it is recommended to further monitor the operation of the junction to determine if there is consistent adherence to the auditors' observations. If it is found that further clarity at the junction could be beneficial, a roundel feature could be created. To create a roundel feature, we could overlay some of the coloured leaves with white ones of the same size at the centre. This would also make the junction more consistent with the signing. We can also overlay the	Reject Audit response and Accept Designer response: This item has not been flagged by any previous RSA, and the design has always shown this layout to be implemented. In the previous arrangement, the roundel was overrun by vehicles. Introducing a roundel or similar feature might lead drivers to assume that everyone will navigate around the junction, which is unlikely based on observations of the previous layout Implementing a TSRGD diagram 1003.4 roundel would go against the whole design philosophy at this location, and provide potential tracking issues, risk providing vehicles with a false impression of priority and further require additional signing/lining to accommodate. The scheme design includes a bespoke surface course pattern that has been laid providing a circulatory guide. If it is found during commission crossing review &	It is felt that the concentric pattern is enough to encourage drivers around the junction without them assuming everyone will do the same. WSP to observe driver behaviour at the junction and feed back to WBC. This is to be undertaken before the RSA 4 is complete.

RSA3 problem	RSA Recommendation	Design Organisation Response	Overseeing Organisation Response	Agreed RSA action
 Problem 6 Location: Parking area for the shops on the south side of the California Crossroads junction – see Appendix B for location. Summary: Vehicles driving through the parking area the wrong way could come into conflict with other vehicles and pedestrians. The layout for the parking area at the shops on the south side of California Crossroads has been changed, with the provision of 'No Entry', "In" and "Out" traffic signs to highlight to drivers that they should travel southbound through this area (whereas previously you could only travel northbound through the parking area). During the site visit, several vehicles were observed to be entering this area from the Avery Corner car park access road, contravening the 'No Entry' traffic signs, and travelling the wrong way through the parking area and sometimes resulting in the road user driving into a parking space and then having to reverse into the shared space area when they leave. This could increase the possibility of a conflict with another vehicle travelling through this area in the correct direction, or it could increase the potential for a conflict with a pedestrian walking through this area when a vehicle is reversing out of a parking space (see also Problem 1). 	It is recommended that the new 'No Entry', "In" and "Out" traffic signs at both ends of the parking area are supplemented with appropriate arrow road markings to further highlight the correct direction that road users should be travelling through this area.	Recommendation Accepted Arrow Road markings to be supplemented at the 'No Entry', 'In' and 'Out' traffic signs to highlight the new one-way traffic layout.	These arrows have been installed	No further action is required.

RSA3 problem	RSA Recommendation	Design Organisation Response	Overseeing Organisation Response	Agreed RSA action
 Problem 7 Locations: Nine Mile Ride (West) / Nine Mile Ride (East) / Finchampstead Road (North) approaches to the junction – see Appendix B for locations. Summary: Adjacent vegetation restricts the visibility of the "New Road Layout Ahead" traffic signs. It was observed during the site visit that adjacent vegetation was restricting the forward visibility of the "New Road Layout Ahead" traffic signs on the Nine Mile Ride (West), Nine Mile Ride (East) and Finchampstead Road (North) approaches to the junction. This could reduce road users' awareness that the junction layout ahead has been changed, which could increase the possibility of a vehicle approaching the junction without giving way to other vehicles (resulting in a collision). 	It is recommended that the vegetation located adjacent to the "New Road Layout Ahead" traffic signs is cut back appropriately so that these signs are clearly visible to road users.	Recommendation Accepted Vegetation to be trimmed back and recorded in the management plan and risk register.	WBC can confirm vegetation highlighted has already been cut back, and notes provided to maintenance teams highlighting the requirement for regular inspections.	No further action is required.

RSA3 problem	RSA Recommendation	Design Organisation Response	Overseeing Organisation Response	Agreed RSA action
Problem 8 Locations: Nine Mile Ride (East) and Finchampstead Road (North) approaches to the junction – see Appendix B for locations. Summary: Lack of any road markings adjacent to the pedestrian refuge islands could increase the possibility of a vehicle colliding with the island. On the Nine Mile Ride (East) and Finchampstead Road (North) approaches to the junction, 'courtesy crossing' facilities have been provided with pedestrian refuge islands in the centre of the crossings, as shown on the photograph below. No road markings have been provided in the centre of the carriageway to highlight the presence of the islands to road users, which may increase the potential of a road user mistakenly travelling too close to an island and colliding into it.	It is recommended that appropriate hatched road markings, with a short length of longitudinal warning line road markings, are provided directly adjacent the refuge islands in these locations.	Recommendation Rejected The addition of hatched road markings from the refuge island could detract from the scheme approach. Traffic sign 610 should suffice.	Agree with designer response.	No further Action required.

RSA3 problem	RSA Recommendation	Design Organisation Response	Overseeing Organisation Response	Agreed RSA action
Problem 9: Location: Nine Mile Ride approximately 70m to the west of California Crossroads – see Appendix B for location. Summary: Dark area next to the new raised table crossing facility.	It is recommended that the vegetation located adjacent to the street lighting column is cut back appropriately (with an allowance for seasonal growth) in order to provide adequate illumination of the carriageway in this location.	Recommendation Accepted Vegetation to be trimmed back and recorded in the management plan and risk register.	WBC can confirm vegetation has been cut back at this location.	No Further Action Required.
As shown on the following photograph, it was observed during the darkness site inspection that vegetation located adjacent to a new street lighting column was creating a dark area next to the new raised table crossing facility, located on Nine Mile Ride to the west of California Crossroads. This could increase the possibility of a road user's eyes not adjusting adequately to the change in illumination, which may lead to them not clearly seeing a pedestrian about to cross the carriageway at the 'courtesy crossing' facility (possibly resulting in a collision). In addition, if a pedestrian chooses to cross the road away from the location of the crossing facility (i.e. in the dark area of the carriageway), a motorist may not clearly see the pedestrian crossing the road ahead, leading to a collision.
