CALIFORNIA CROSSROADS

Stage 3 Road Safety Audit

REPORT NUMBER: UK-70104511/RSA3/1/0

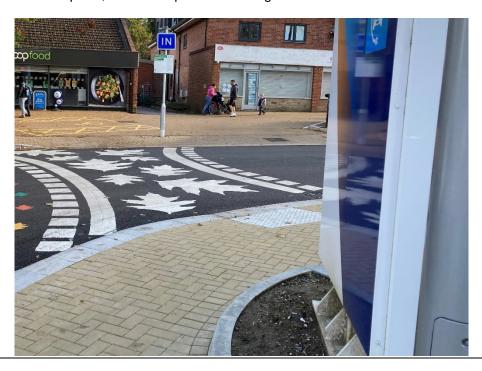
As shown on the following photograph, it was observed that the petrol station fuel price totem restricts the visibility from the new pedestrian crossing point on the south side of the western Nine Mile Ride junction approach (i.e. obstructing the visibility of vehicles that are about to turn left from Finchampstead Road onto Nine Mile Ride).

Therefore, it is still recommended that the local highway authority consults with the petrol station owner to determine whether the petrol station sign can be relocated to a position where it will not restrict the visibility from the adjacent pedestrian crossing point (if this has not been done already).

Accepted: It is thought the totem on site now is not the one present when the visibility splay was measured. Please can WBC confirm a conversation was had with the petrol station owner and confirm its location, so we can assess if the splays are different to our original assessment. WSP to advise once the location is confirmed.

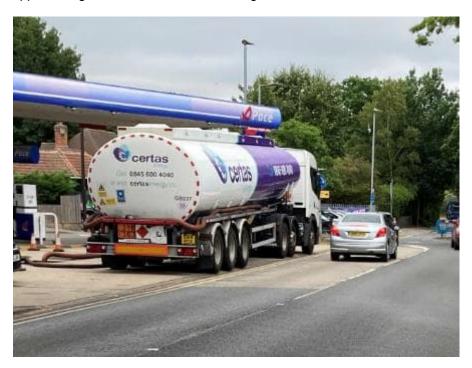
It was observed during the site visit that a petrol tanker making a delivery at the Pace petrol station stops at the location shown on the photograph below. A stationary petrol tanker in this location will significantly restrict the visibility of vehicles approaching from the south-west on Finchampstead Road from the proposed pedestrian crossing point on the north-west side of Finchampstead Road (on the south-western corner of the California Crossroads junction).

This could increase the possibility of a pedestrian crossing Finchampstead Road in this location when a vehicle is approaching from the south-west, leading to a collision.

It is recommended that the designer consults with the petrol station owner to determine whether petrol tankers can stop at the garage in an alternative location where the tanker will not obstruct the visibility sightline from the proposed pedestrian crossing point.

If this is not feasible, it is recommended that the pedestrian crossing facility on Finchampstead Road is not provided in this location, or moved to an appropriate location where adequate visibility of vehicles approaching in all directions can be provided from the crossing points.

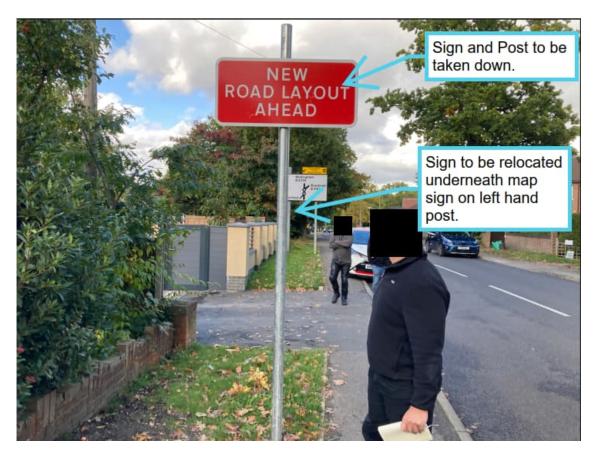
It was observed during the site visit that the "New Road Layout Ahead" traffic sign on this approach to the junction was partially restricting the visibility of the adjacent map-type advance direction sign. Therefore, this problem remains relevant.

Accepted: Temporary sign to be moved to a more appropriate location, as shown below.

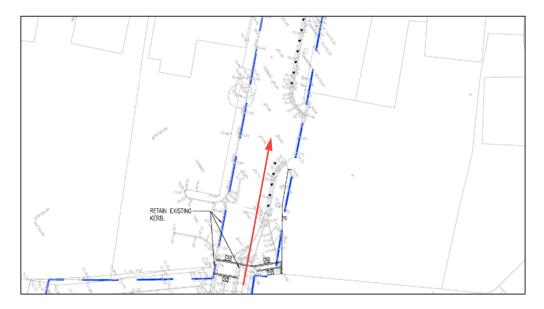
In the proposed layout, visually impaired pedestrians walking from the car park footway could mistakenly walk straight ahead onto the access road carriageway (as the northern end of this footway will be flush with the carriageway surface) and potentially into the path of a vehicle travelling towards the car park – see example below. This could lead to a visually impaired pedestrian being struck by a vehicle on the carriageway.

It is recommended that an appropriate feature is provided in this location, such as tactile paving, in order to direct visually impaired pedestrians from the car park footway towards the north-east side of the access road, so that they will walk behind the proposed bollards rather than into the path of an oncoming vehicle.

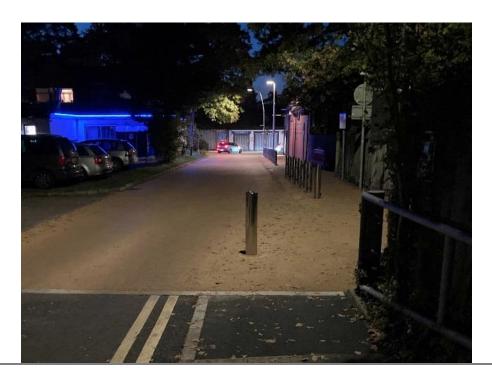
As shown on the following photograph, no tactile paving has been installed in this location in order to direct visually impaired pedestrians between the existing footway and the north-east side of the access road, as suggested by the Design Team in response to this problem. Therefore, this problem remains relevant.

Accepted: WBC to ensure tactile paving is added as per construction drawings number 8199-LA-001 C04

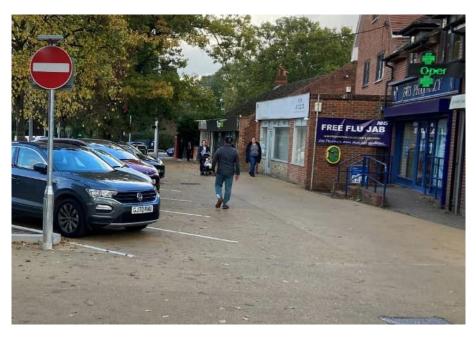
In the previous road layout in this location, there was a footway provided adjacent to the row of shops on the south side of the California Crossroads junction. This footway has been removed as part of the scheme. It was observed during the site visit that several pedestrians were walking through the centre of this area in locations where vehicles will be turning into or out of the echelon parking bays (as shown on the photograph below).

Anecdotal comments from some members of the public suggested that the new layout has increased the possibility of conflicts between vehicles and pedestrians walking through the parking area.

It is recommended that appropriate 'virtual footway' road markings are provided at the back of the parking area (directly adjacent to the shops) in order to encourage pedestrians to travel through this area away from the locations where vehicles will be turning into or out of the parking bays.

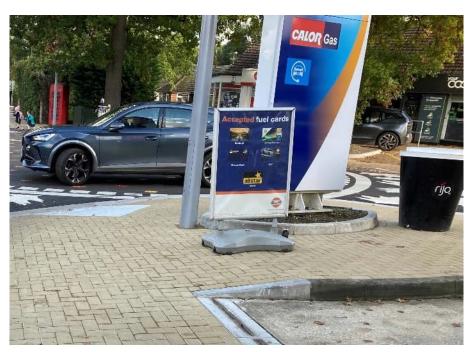
As shown on the following photograph, there is a temporary petrol station sign and a 'coffee cup' feature positioned on the new footway on the south-western corner of the junction. During the site visit, it was observed that the adjacent petrol station fuel price totem restricts the visibility to / from the adjacent pedestrian crossing points (see Problem 4 in Section 2.3 of this report), and the temporary sign and 'coffee cup' feature could further restrict the inter-visibility at the crossing points.

This could increase the possibility of a driver not clearly seeing a pedestrian waiting at one of the adjacent crossing points (particularly a child pedestrian or a wheelchair user), which could increase the possibility of a pedestrian crossing the carriageway when a vehicle is turning onto Nine Mile Ride (West) or Finchampstead Road (South), possibly leading to a collision.

In addition, the temporary sign and 'coffee cup' feature could present an obstruction on the footway which could increase the possibility of a pedestrian tripping over one of these features (particularly a visually impaired pedestrian).

It is recommended that the temporary sign and 'coffee cup' feature are removed or relocated to an alternative appropriate location where they will not obstruct any footways or visibility sight lines.

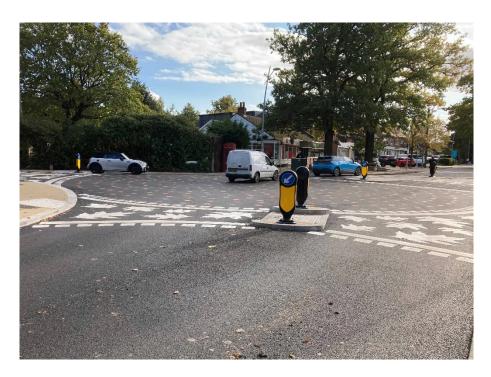
The proposed scheme has replaced the previous double mini-roundabout junction layout, and replaced it with an unconventional junction layout where it may not be completely clear to road users who has priority when travelling through the junction.

However, map-type advance direction traffic signs have been installed (or are planned to be installed) on each approach, which shows that the junction has a double-roundabout layout. It was observed during the site visit that motorists were generally using the junctions like mini-roundabout layouts (i.e. they were giving way to the right when entering the junction from one of the approaches).

However, due to the unusual layout, occasionally some road users (particularly those travelling through the junction for the first time) could be confused regarding how to negotiate the junction layout. Typically this would result in a driver entering the junction in a cautious manner, however this could also increase the possibility of a motorist entering one of the junctions and not giving way to another vehicle approaching from the right (which may lead to a collision) or a road user could be concentrating on how to negotiate the junction and then failing to give way to a pedestrian crossing the carriageway using one of the new 'courtesy crossing' layouts.

It is recommended that appropriate mini-roundabout central island road markings to TSRGD diagram 1003.4 (with the circular central island marking and the arrow markings) are provided in the centre of the two individual junctions at California Crossroads. This could reduce driver confusion, provide a more conventional junction layout, and encourage road users to give way to the right at the 'roundabout' entries.

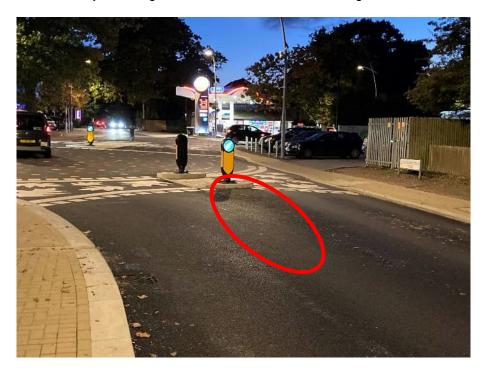
carriageway to highlight the presence of the islands to road users, which may increase the potential of a road user mistakenly travelling too close to an island and colliding into it.

It is recommended that appropriate hatched road markings, with a short length of longitudinal warning line road markings, are provided directly adjacent the refuge islands in these locations.

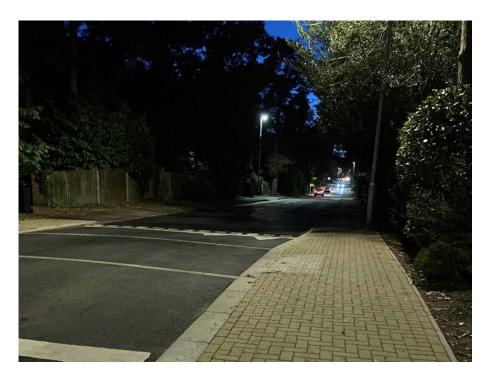
As shown on the following photograph, it was observed during the darkness site inspection that vegetation located adjacent to a new street lighting column was creating a dark area next to the new raised table crossing facility, located on Nine Mile Ride to the west of California Crossroads. This could increase the possibility of a road user's eyes not adjusting adequately to the change in illumination, which may lead to them not clearly seeing a pedestrian about to cross the carriageway at the 'courtesy crossing' facility (possibly resulting in a collision).

In addition, if a pedestrian chooses to cross the road away from the location of the crossing facility (i.e. in the dark area of the carriageway), a motorist may not clearly see the pedestrian crossing the road ahead, leading to a collision.

It is recommended that the vegetation located adjacent to the street lighting column is cut back appropriately (with an allowance for seasonal growth) in order to provide adequate illumination of the carriageway in this location.
